## **TECHNICAL SERVICE BULLETIN 10003**

**MODEL(S):** 25LTDST, 25NWST, 25WXNWST, 25WXST

**DESCRIPTION:** Squealing on transmit, only when Soundtracker is engaged.

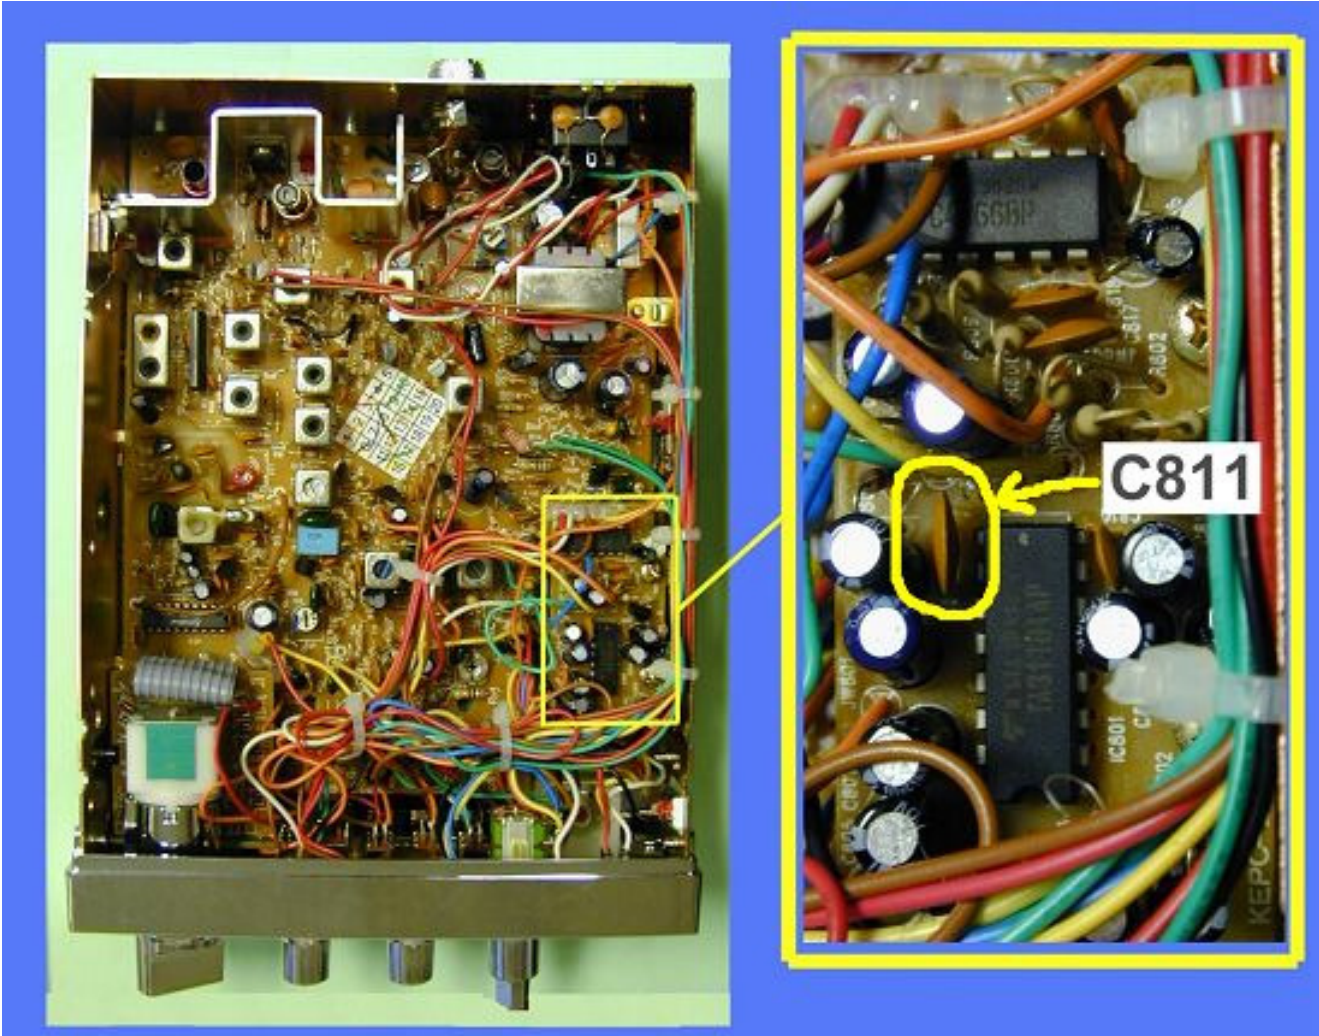
If the radio still squeals, remove C811 on the Soundtracker board. The Soundtracker board is a small board along the right-hand edge of the radio (with the radio is upside-down). C811 is located next to pin 9 of IC801 (IC801 is a TA31101). Refer to page 2 for a diagram of the location.

**ACTION:** Check the SWR of the antenna, make sure it is below 3. Optimally the SWR should be below 2.5.
