COBRA 148GTL-DX (LATE)

Receive Widebanding

MB CHASSIS - SERVICE NOTES

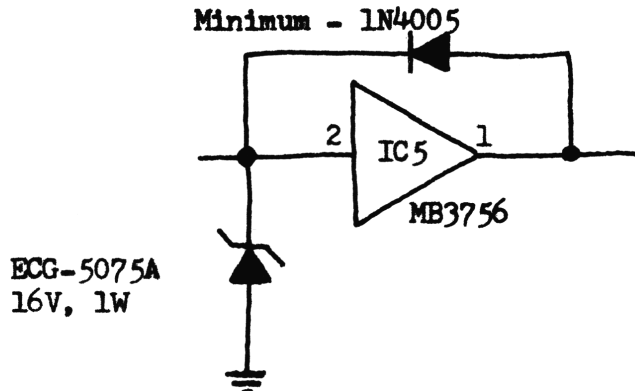
1. Voltage Regulator (usually numbered IC-5; MB3756) going bad?
Especially in mobile units...

Recommended additional parts should be added to circuitry as shown:
Zener Diode and rectifier diode.....
