CORRECTIONS

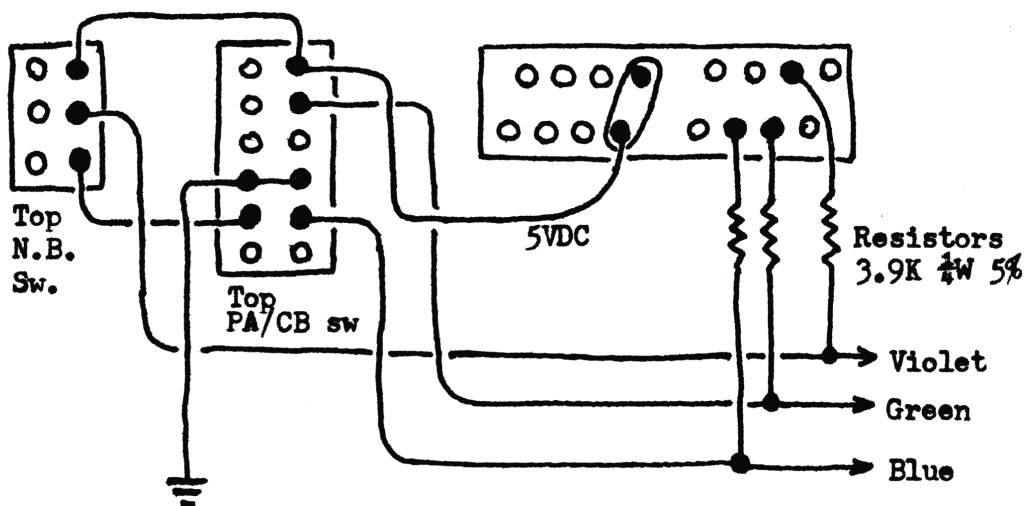
(*) Volume 10, page 49: This modification was drawn up wrong, I know as sent it in myself. The correction to drawing is below.
NOTE: Custom Conversion #18 is available from Selman Enterprises on this unit (26.525-27.795MHz).

These wires are from the
PLL cage.....
