BALANCED MODULATOR BOARD PCB D

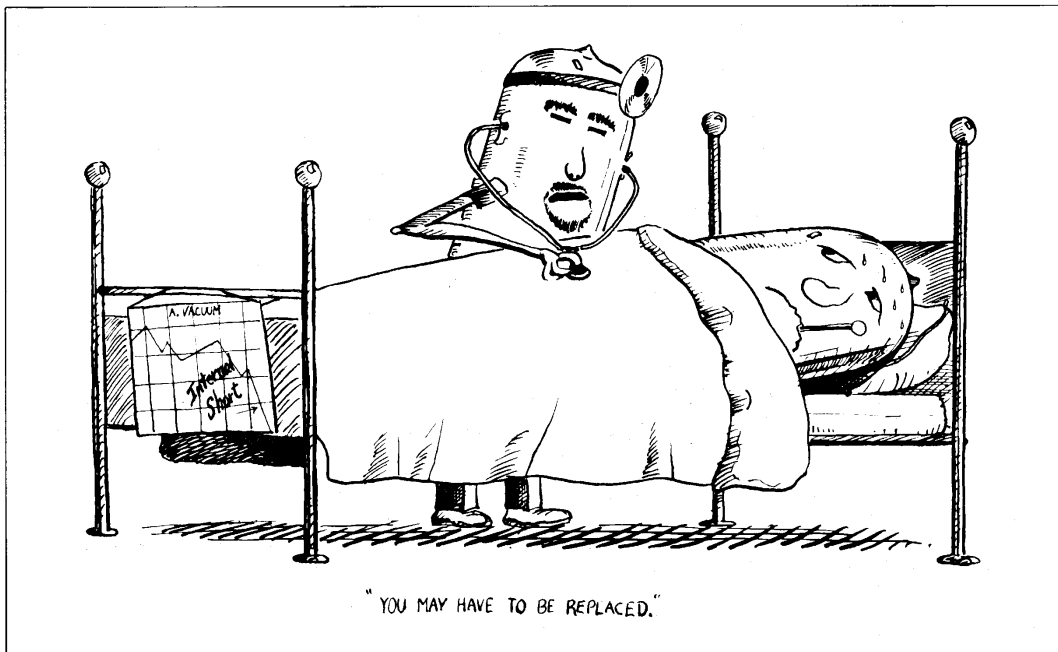
TUBE TROUBLE LOCATOR

MOST PROBABLE CAUSE

SYMPTOM	6BQ7A V 300	6BK7B V 301	6BK7B V 302	6BA6 V 400	6GH8A V 401	12AX7 V 402	6BA6 V 500	6BA6 V 501	6GH8A V 502	6GH8A V 600	6GH8A V 601	6GH8A V 602	6L6 GC V 603	12BY7A V 700	6L6GC V 701
WEAK OR NO OPERATION	○	○	○	○	○	○	○	○	○	○	○	○	○	○	○
AM AND SSB RECEIVE	○	○	○	○	○	○	○	○	○	○	○	○	○	○	○
AM RECEIVE	○	○	○	○	○	○	○	○	○	○	○	○	○	○	○
SSB RECEIVE	○	○	○	○	○	○	○	○	○	○	○	○	○	○	○
MANUAL RECEIVE	○	○	○	○	○	○	○	○	○	○	○	○	○	○	○
AM AND SSB TRANSMIT	○	○	○	○	○	○	○	○	○	○	○	○	○	○	○
AM MODULATION	○	○	○	○	○	○	○	○	○	○	○	○	○	○	○
SSB TRANSMIT/ MODULATION	○	○	○	○	○	○	○	○	○	○	○	○	○	○	○
SSB RECEIVE MICROPHONIC	○	○	○	○	○	○	○	○	○	○	○	○	○	○	○
IMPROPER S-METER	○	○	○	○	○	○	○	○	○	○	○	○	○	○	○
SQUELCH	○	○	○	○	○	○	○	○	○	○	○	○	○	○	○
