PLEASE
NOTE!

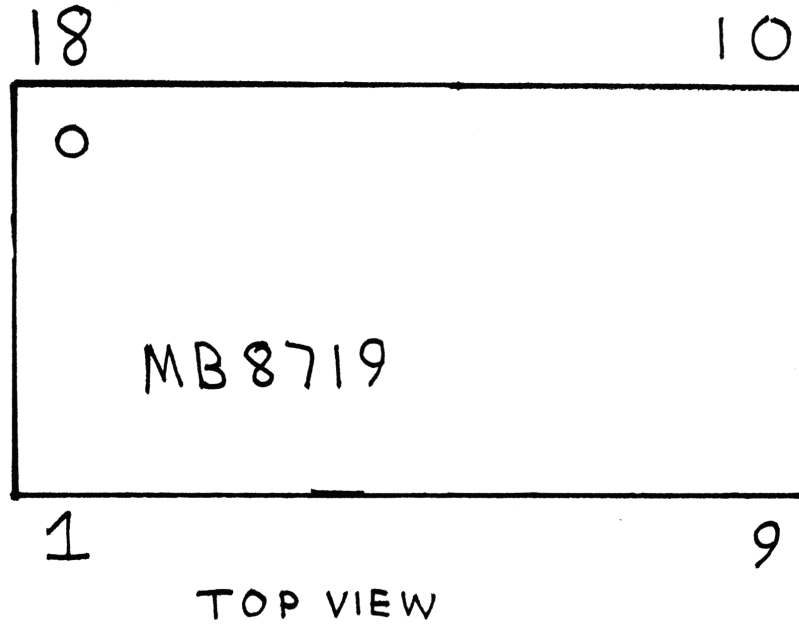
On the MB8719 Chips, for some reason, Pin 1 is not where the dot is, that is Pin 18. So be careful when you locate Pin 10.

Pin 18 is chip ground.

Pin 9 is chip 8V source.

Pin 10 is either no connection or is grounded.
